PRELIMINARY BUILDING EVALUATION REPORT

BRIDGEWATER FIRE DEPARTMENT

22 School Street
Bridgewater, Massachusetts

September 9, 2010

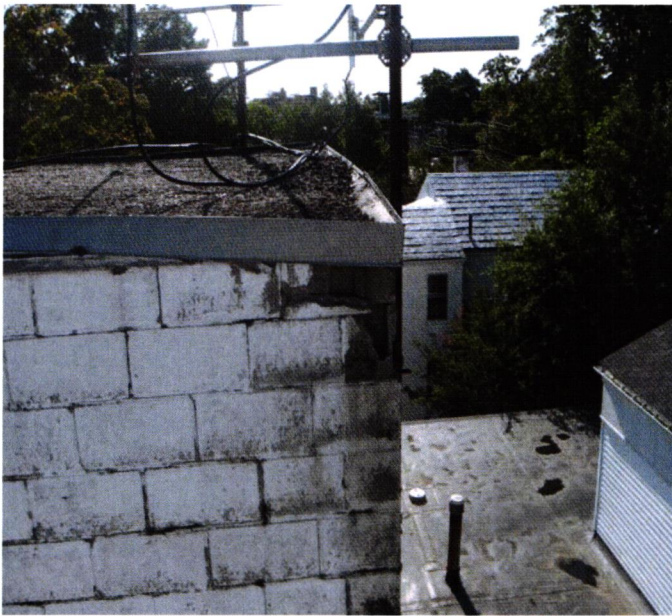
At the tower at the back of the building, from the rear, the front right corner and the rear right corner, the block is broken and the flashing is

pulling up and the roof is deflecting in. This is going to need to be replaced or removed in its entirety.

CMU damage at tower.

Hose Tower. The hose tower has two (2) wood framed platforms and a metal ladder going up the inside of the tower. As stated before, the wood frame roof of the tower is failing and this area should be addressed immediately. Removal of the tower is recommended.

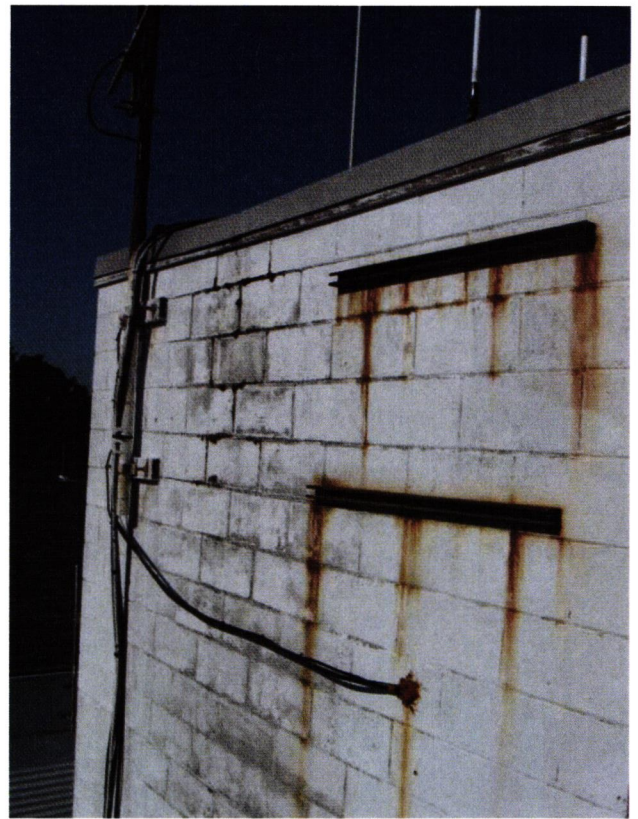
Water damage at block.

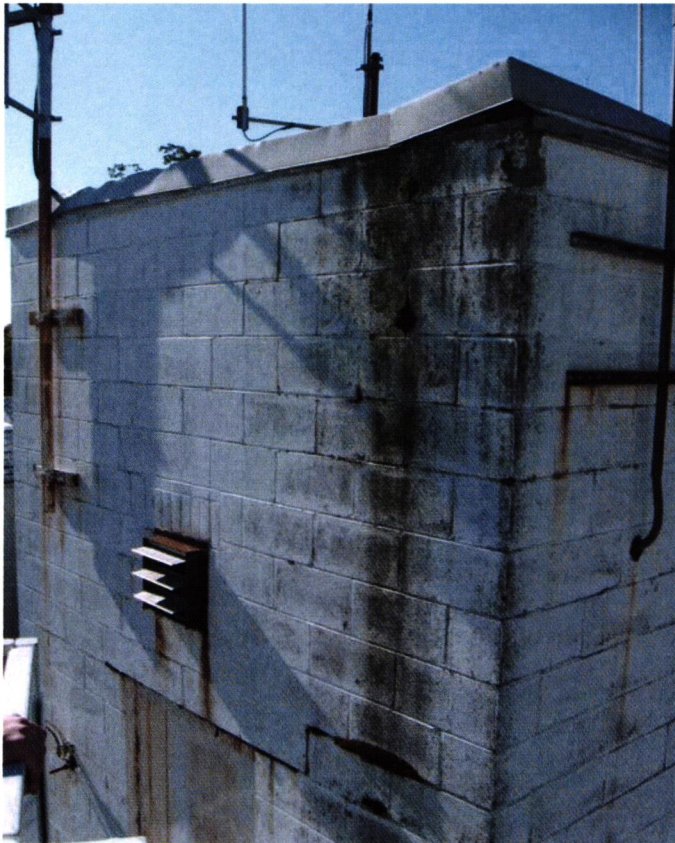
CMU block cracks and water leak.

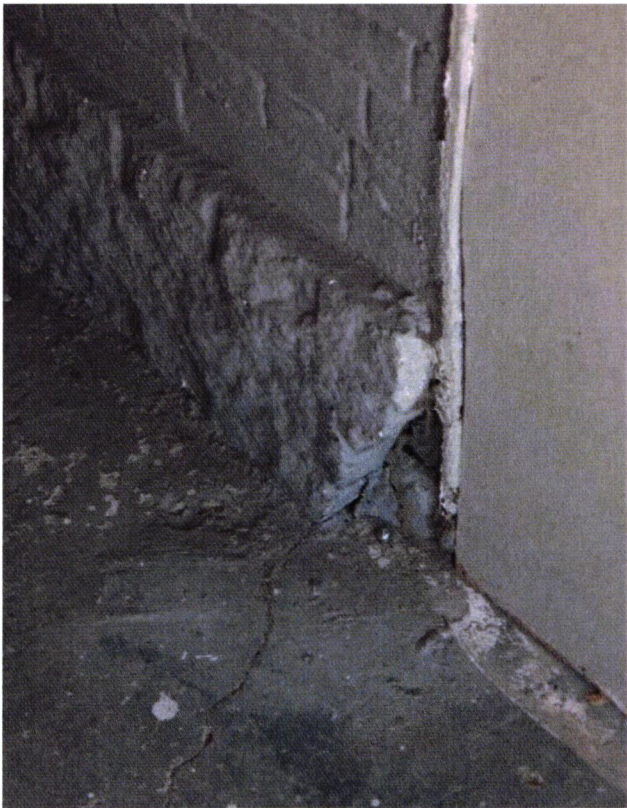
Cracked slab and granite foundation base.

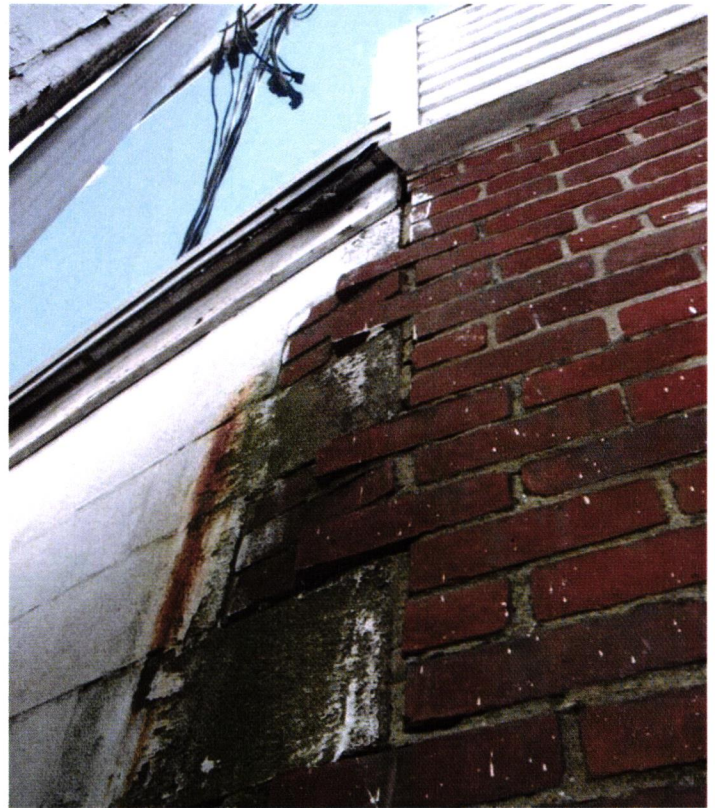
Mortar separation at brickwork and rotted trim.

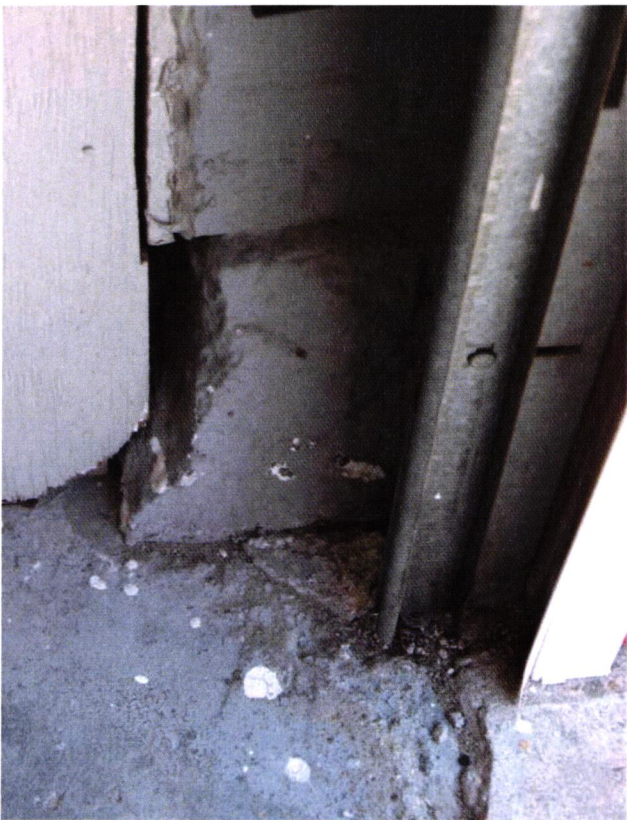
Block damage at overhead door.

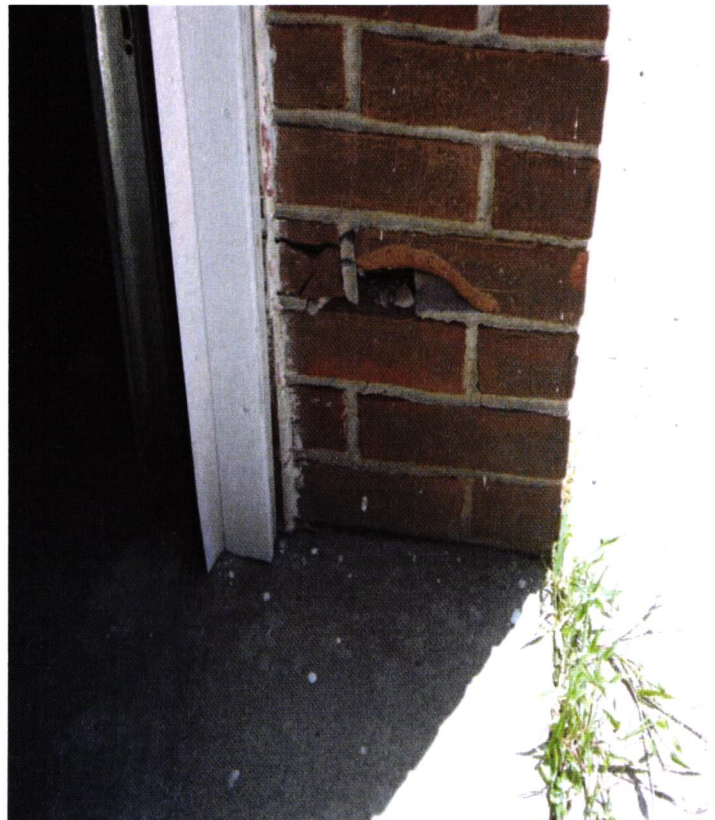
Brick damage at overhead door.

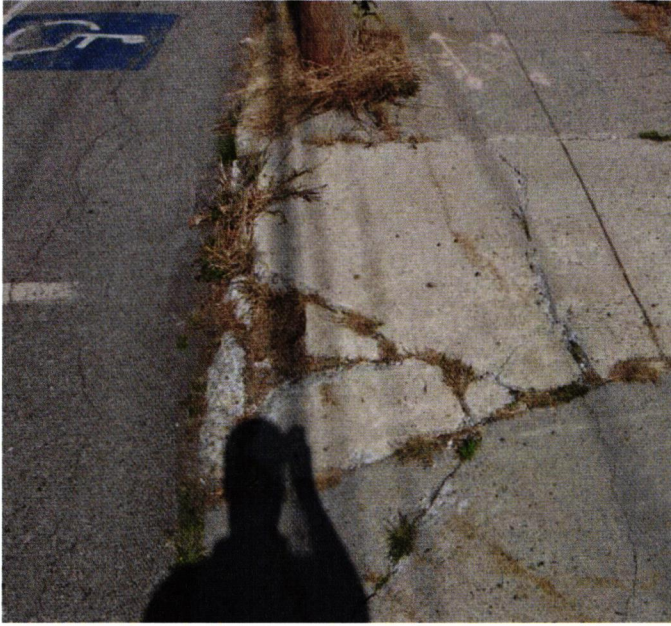
Driveway. The concrete paving at the front of the building, where the trucks park, is cracked in several locations. There are weeds growing up through the cracks. Some areas are broken and heaved, causing uneven surfaces. This will need repair work.

Front concrete pad needs removal & reconstruction.

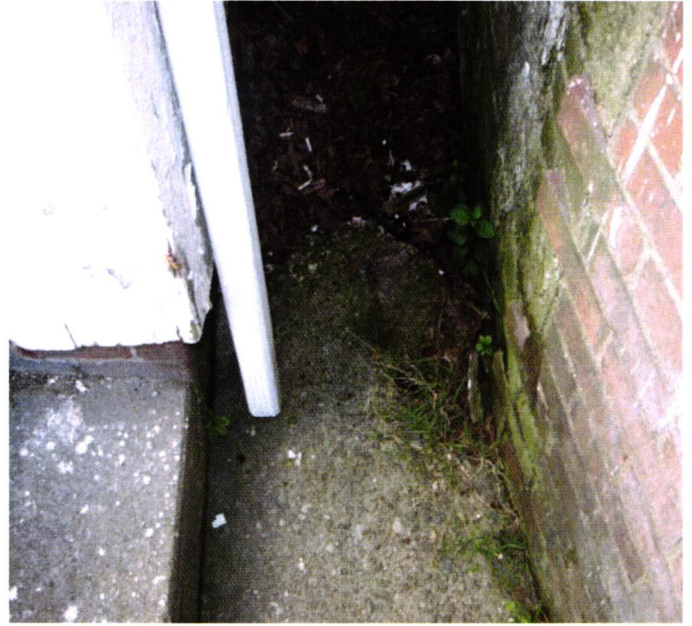
Water damage. Space between buildings.

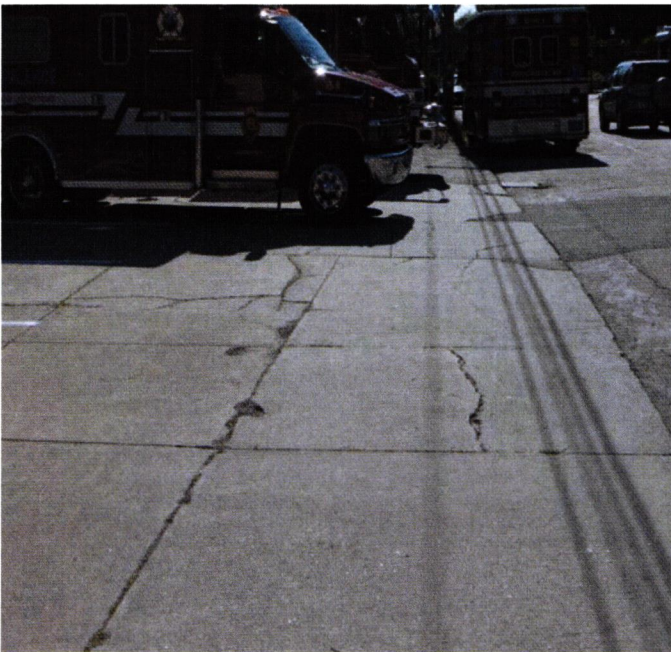
Cracks in concrete street pad.

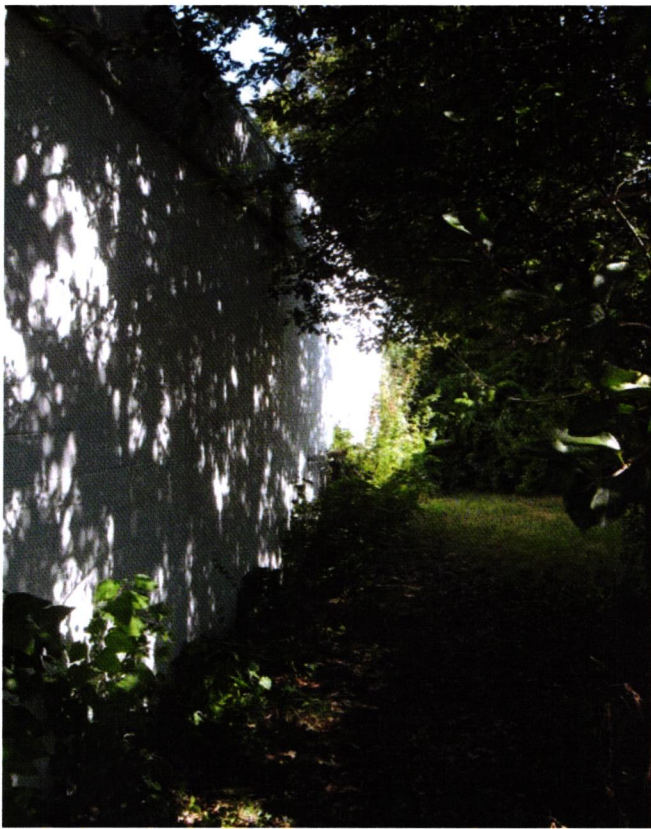
Landscape area around building to be cut back.

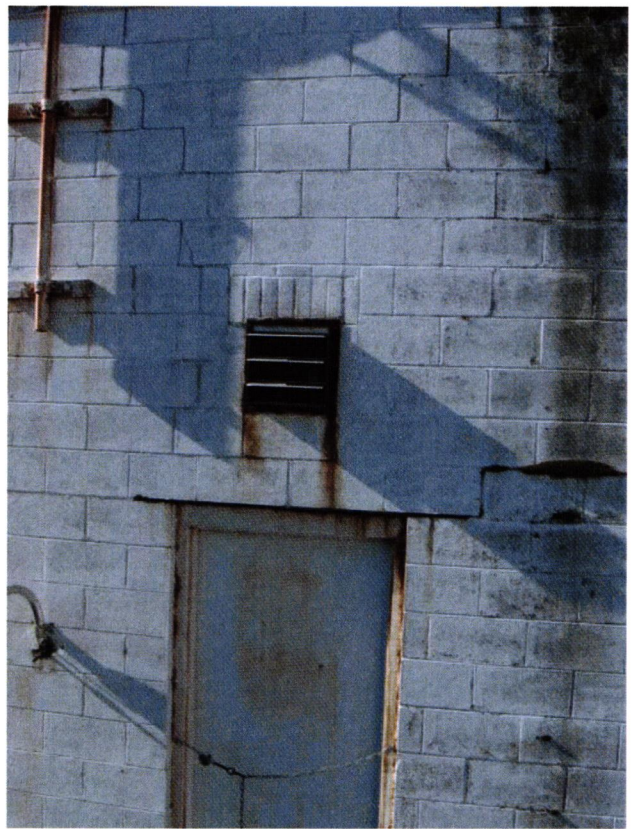
Water damage CMU.

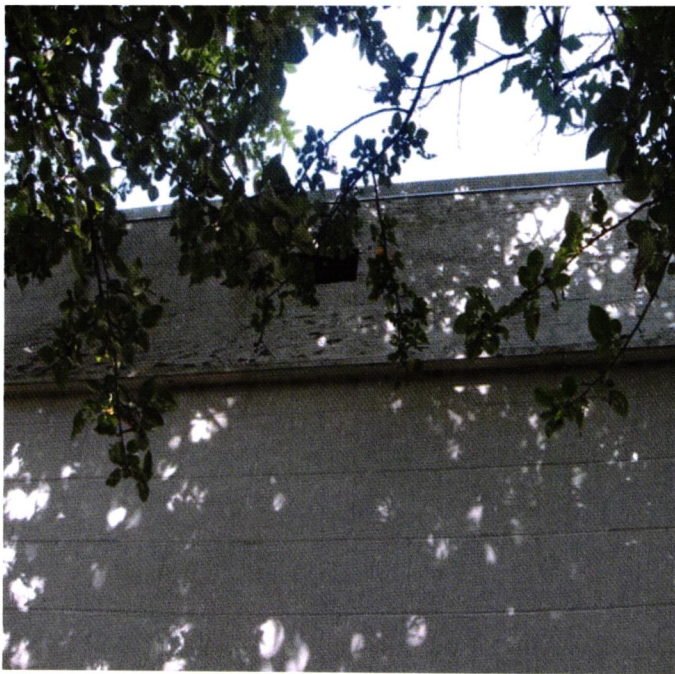
At the top of the first floor, below the roof- line, is a painted plywood and wood fascia band. Paint is peeling on the fascia. This is more of a maintenance issue. The front of the building, first floor, is brick veneer. The right side of the building is painted CMU. The front of the building is 4" brick veneer with 8" CMU backup. The side of the building and the rear of the building is 12" painted CMU. The front brick is in average shape with a mixture of brick-type used depending on when that portion was built. The foundation is granite stone to poured concrete and varies in each old/new section.

Wood band needs repair and repaint.

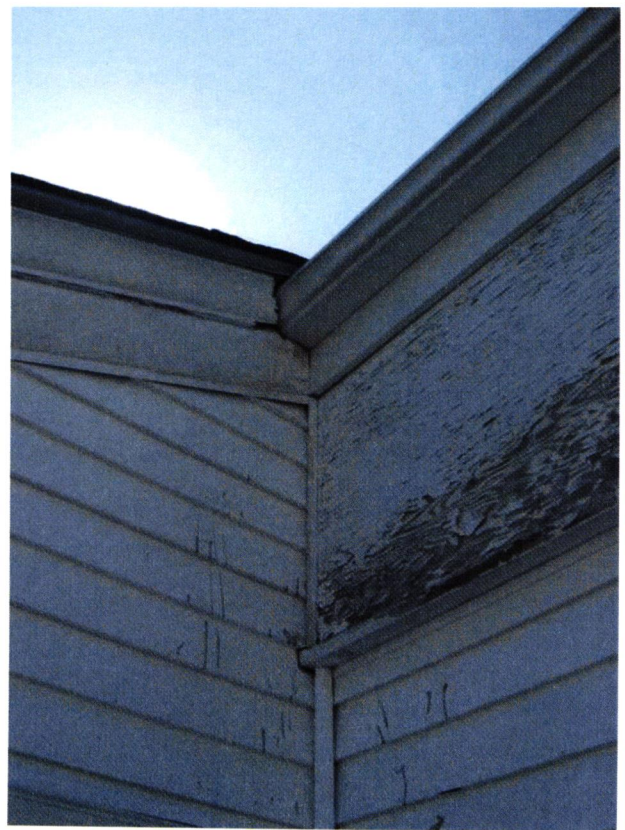
Rotted trim/wood siding in disrepair.

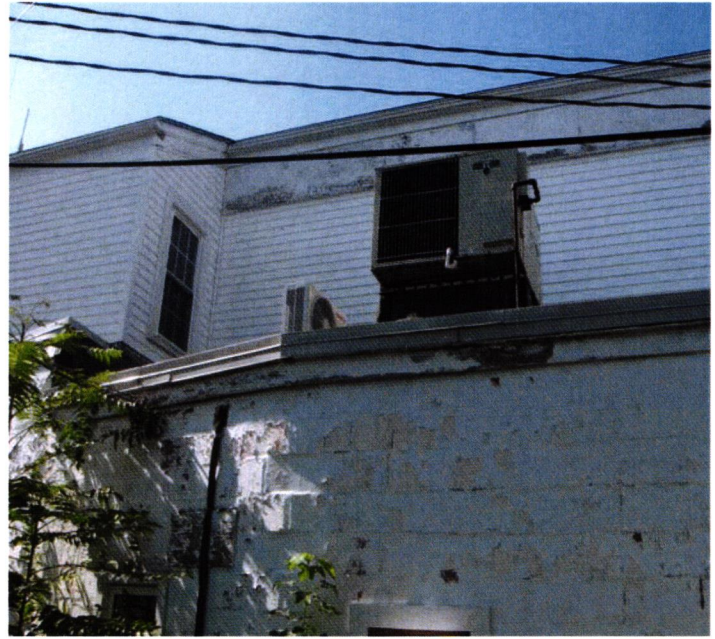
Water infiltrated CMU. Rotted trim.

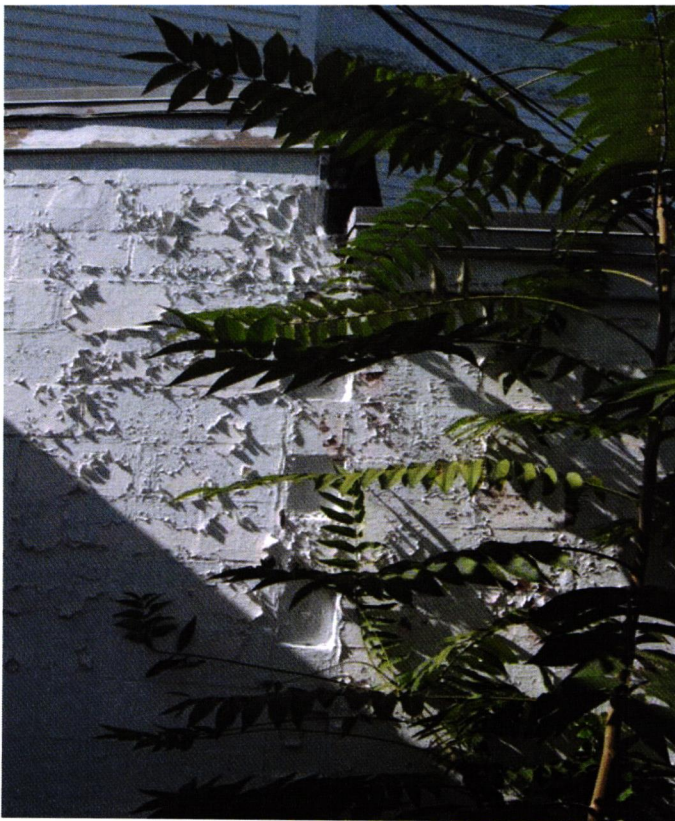
Paint peeling due to water entering block work.

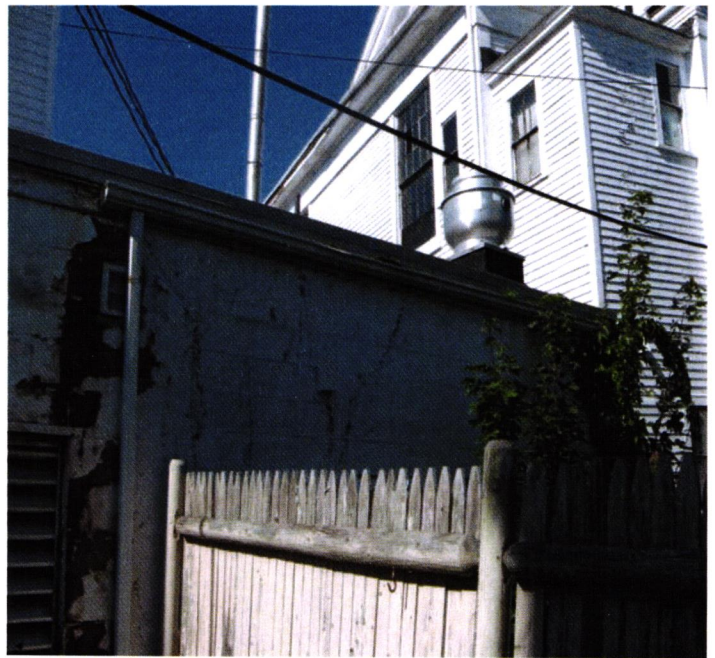
Roof flashing allowing water in block causing mortar to fail and paint to peel.

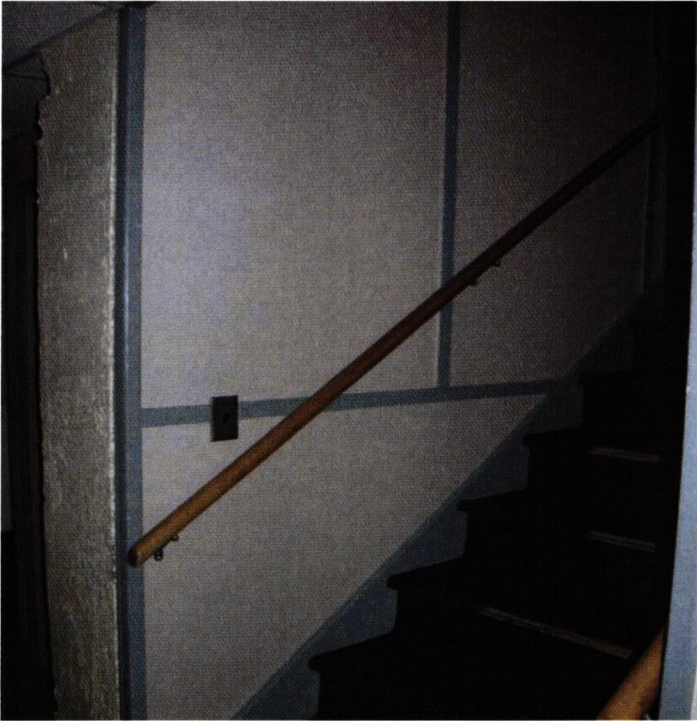
Second Floor. The stairway to the second floor has an acoustical ceiling and painted gypsum walls, wood stairs. The stair tread and risers are damaged. This stair does not meet current codes. On the second floor is the sleeping area; one large open area with several beds and wooden chairs. There is one (1) bed tucked around the corner that is the female fire fighter's sleeping area. Adjacent to this area is also a single bathroom with a shower stall. This room has an acoustical tile ceiling, vinyl sheet

Wood stairs – not code compliant.

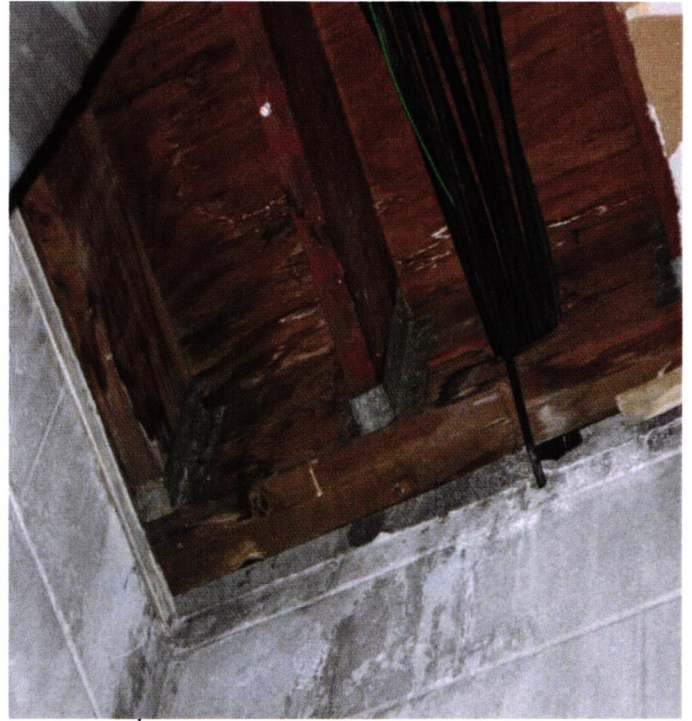
2 x 8 – 2nd Floor roof joist – no insulation.

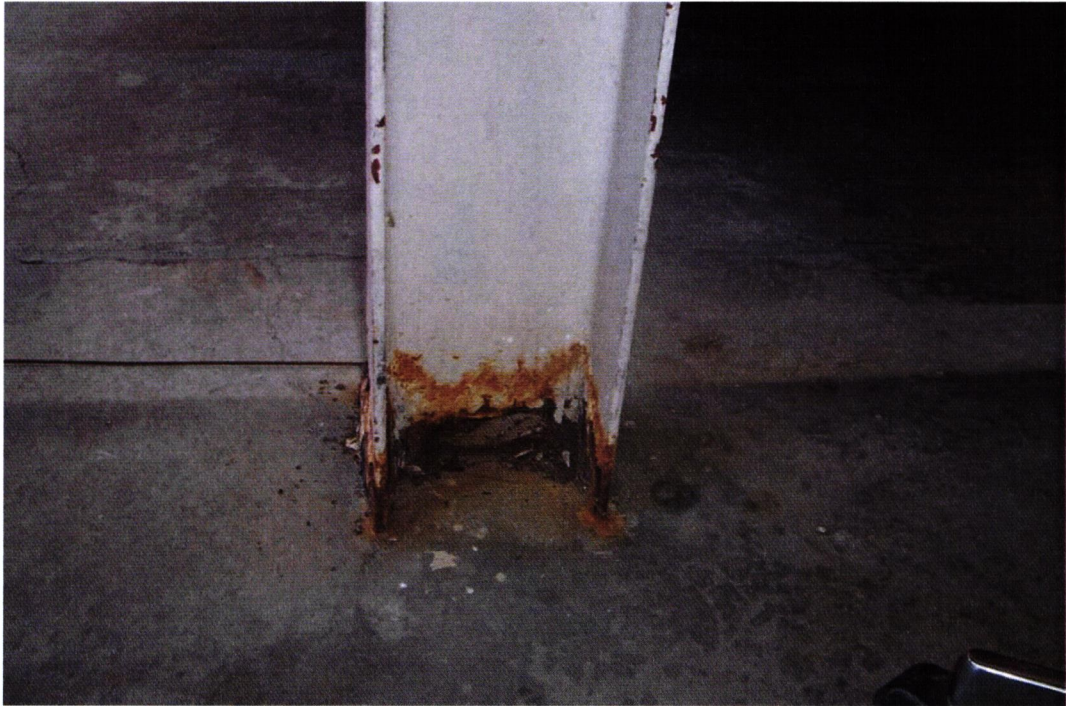
Photo 4.: Corrosion completely through the web of Apparatus Room steel wide-flange column.

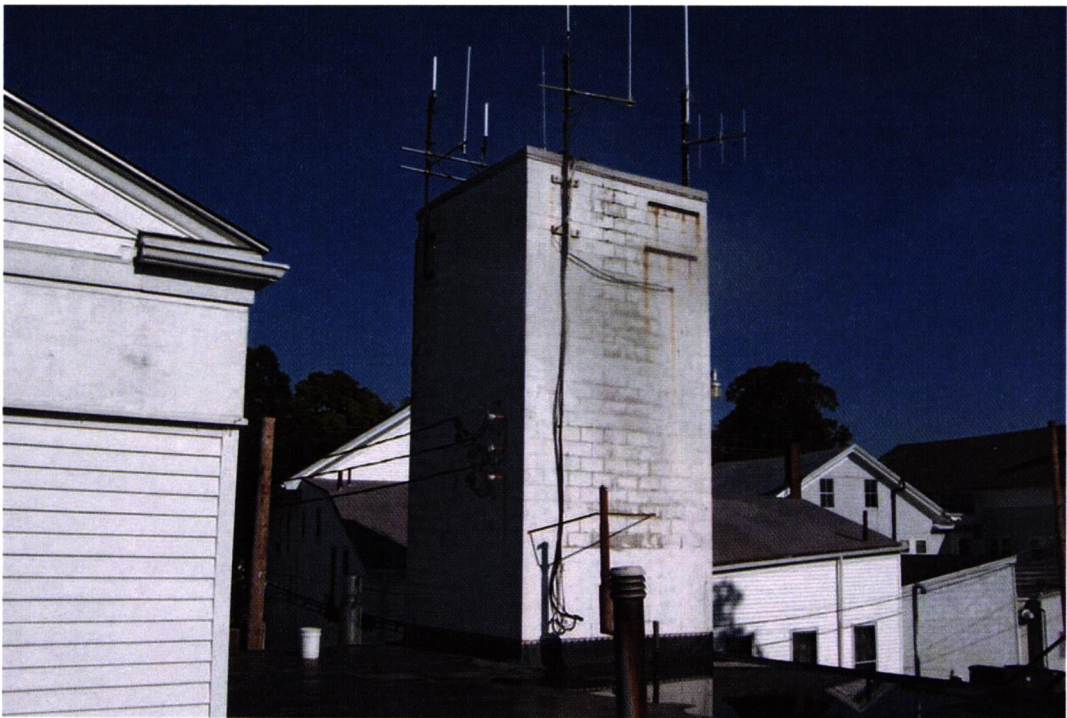
- B. **Present Condition:** Except for the items specifically noted below, the building appears to be, for the most part, in reasonably good condition. We saw no cracking of any significance in masonry walls or in concrete foundation walls. Wood floors and roofs appeared to be reasonably plumb and level, except where roofs have been intentionally pitched for drainage (see Photo 11.). There was no evidence of significant wood rot or insect damage, nor was there extensive corrosion of steel members. A few minor exceptions to this are noted, as follows:
1. One interior steel wide-flange (WF) column has suffered localized but significant corrosion, to the point where the web has rusted completely through (see Photo 4.).
 2. Wood joist framing over Hose Drying tower has deteriorated, with partial collapse (see Photos 5. and 6.).

3. Masonry wall of Hose-Drying tower, near top, shows cracking and other damage to masonry walls.
- C. **Building Codes:** It is quite likely that the Town of Bridgewater had no building code when the original station was built. Since the 1st edition of the Commonwealth of Massachusetts – State Building Code did not become effective until 1975, it's almost as likely that many of the additions that, along with the original building, make up the present fire station were not constructed under the State Building Code, but under whatever building code the Town of Bridgewater may have developed on their own in the intervening years between construction of the original building and construction of the additions. Any future construction done on this building will likely be subject to the provisions of the 8th (or later, depending on timing) edition of the State Building Code. The 8th edition became effective on August 6 of this year, and the six-month overlap “grace” period will expire on February 6, 2011. It's unlikely that plans could be completed for new construction in time to be permitted under the 7th edition of the code.

Photo 5.: Photo of Hose-Drying tower. Wood roof framing of the tower has deteriorated and suffered partial collapse, and masonry walls near the top of the tower show cracking and other damage.

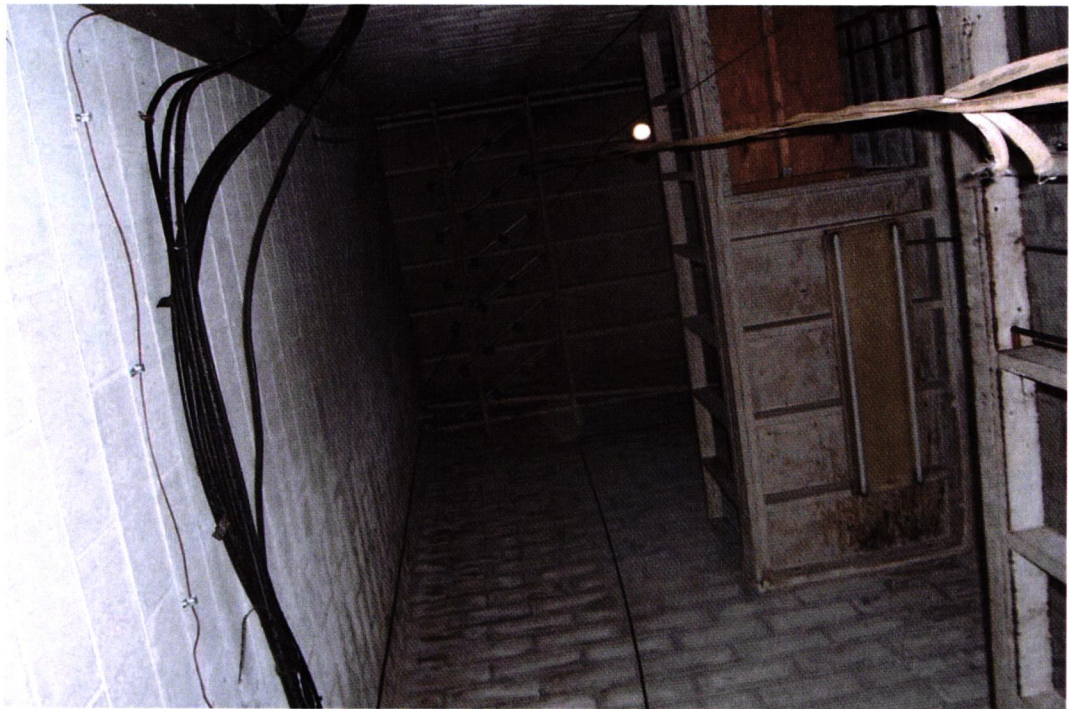
Photo 6.: View up into Hose-Drying tower from floor. Note second roof joist from bottom of photo is skewed, due to roof failure and partial collapse.

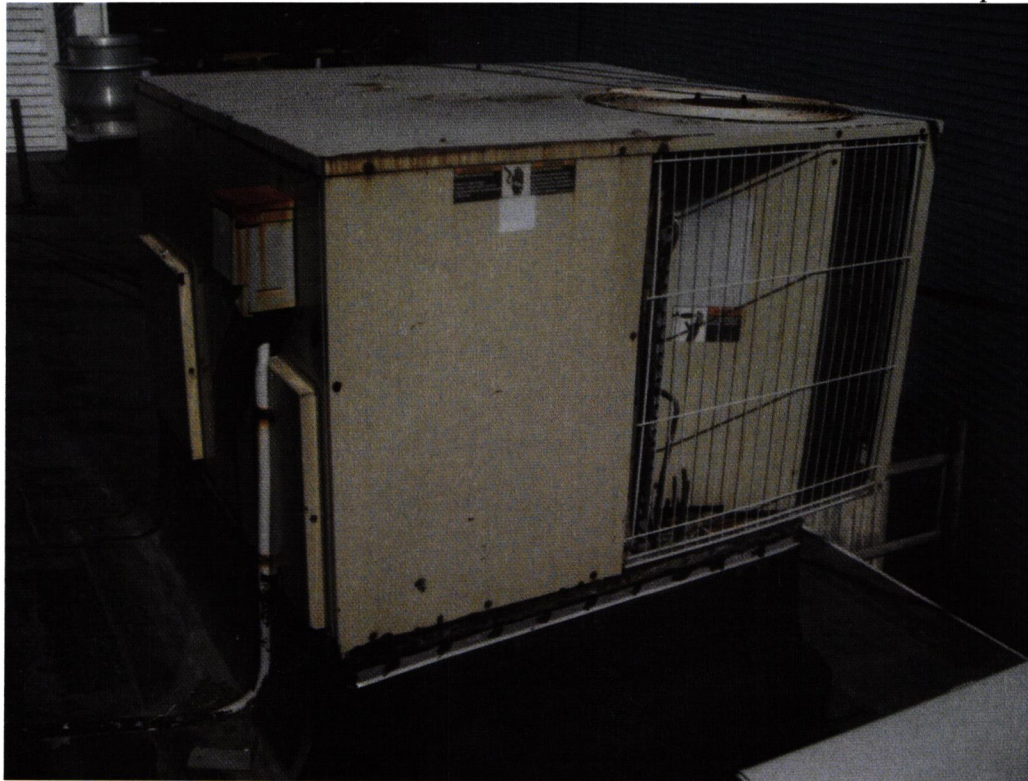
NO. 4

The officers' room and first floor restroom were served by a rooftop-mounted packaged unit located above the space that has not been working for some time. Ductwork from this unit has been disconnected and abandoned above the ceiling. Station personnel report roof leaks in the vicinity of this unit and it appears that the abandoned rooftop unit may be the cause of weather infiltration.

Abandoned Rooftop Unit

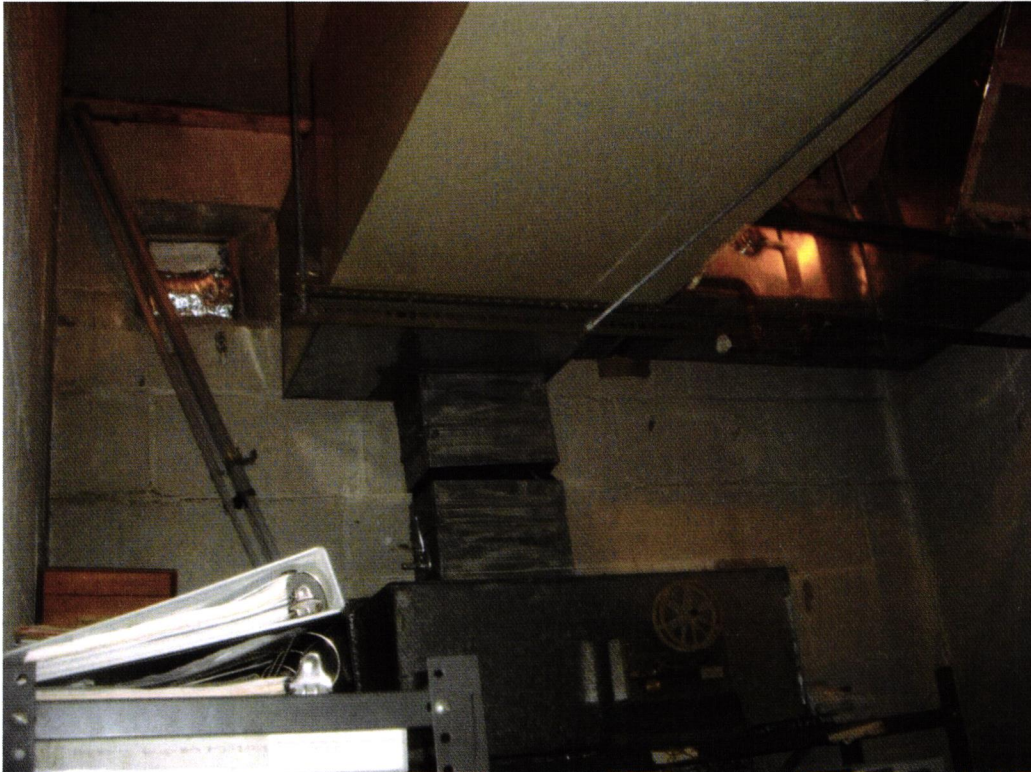
NO. 5

Leaking Fan Coil
