PRELIMINARY BUILDING EVALUATION REPORT

BRIDGEWATER FIRE DEPARTMENT

22 School Street
Bridgewater, Massachusetts

September 9, 2010

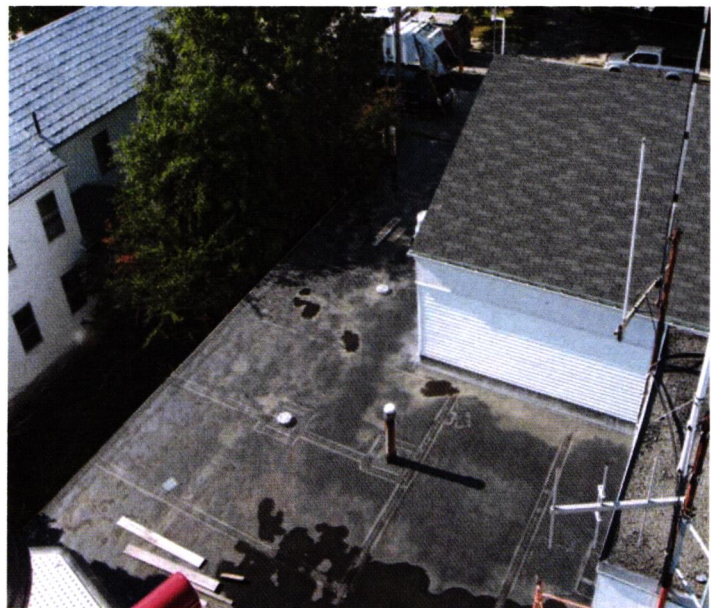
Membrane roof over 3-bay garage.

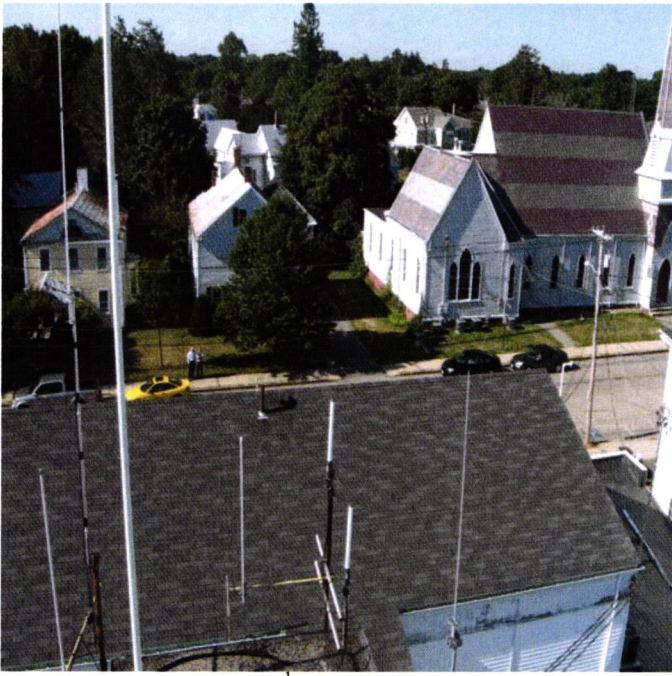
Roof. The second-story roofing on the building is asphalt shingles on the truss framing floor roof section. This area is in good condition. The tower is built up asphalt and gravel on plywood over wood joist. This roof has failed with the flashing lifting up, separating, and water infiltration on all four sides of the tower. The first floor roof section is EPDM single ply roofing. A previous report stated that it appears to be about 15 years old. Several areas of this roof show signs of patching at corners and flashing in an attempt to repair leaks. There are several areas of ponding on this roof. We have been told that many of the pieces of equipment on this roof do not operate properly and are not used. Flashing issues at this equipment are also a problem. The insulation below roof must be wet from leaks. This will compromise the R values and needs replacement. A roofing report was prepared by Russo Barr Associates dated March 31, 2010.

Shingle roof above 2nd floor living quarters.

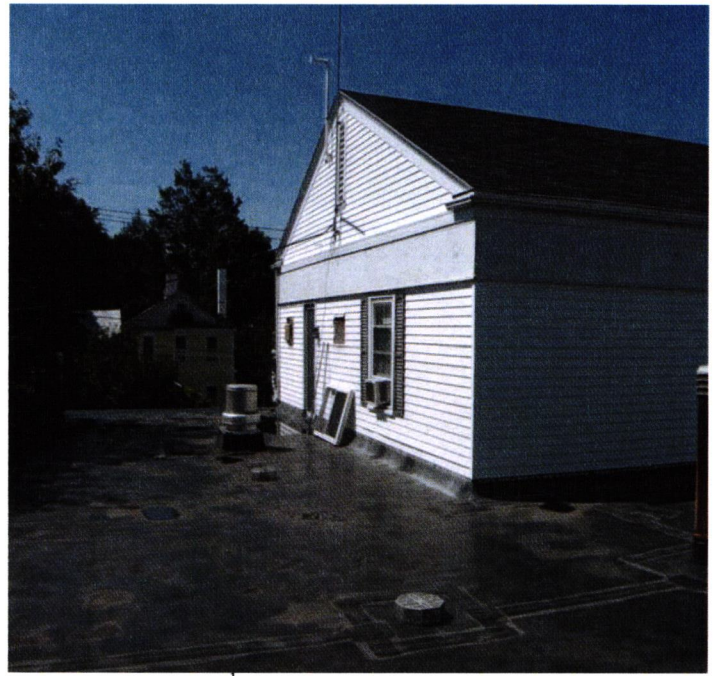
EPDM roof at 2nd floor emergency exit.

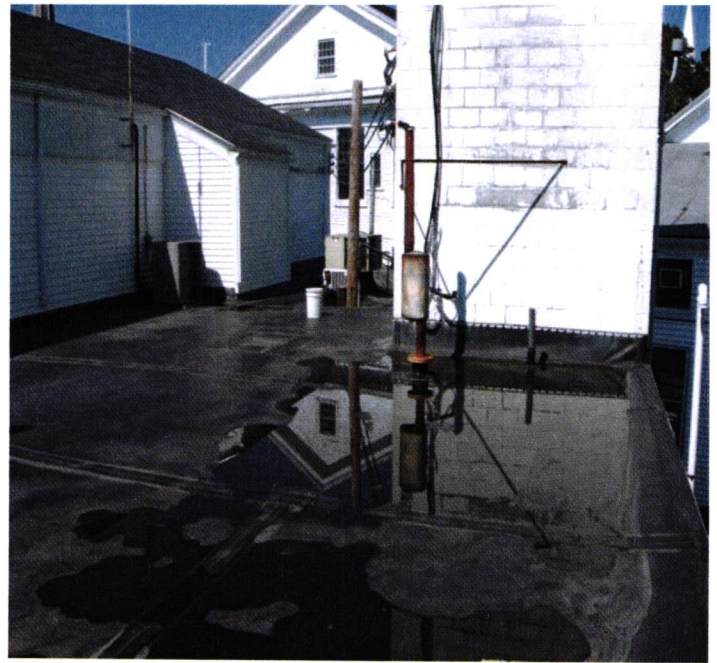
EPDM at base of tower.

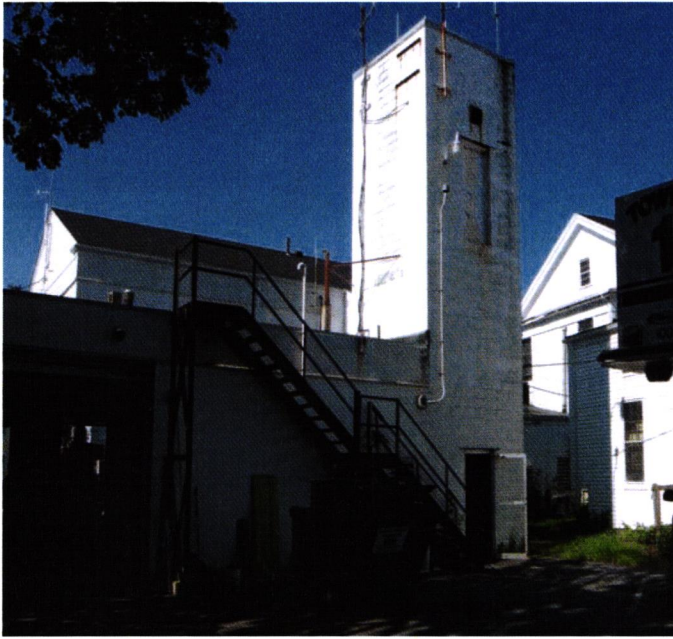
Second Floor. The stairway to the second floor has an acoustical ceiling and painted gypsum walls, wood stairs. The stair tread and risers are damaged. This stair does not meet current codes. On the second floor is the sleeping area; one large open area with several beds and wooden chairs. There is one (1) bed tucked around the corner that is the female fire fighter's sleeping area. Adjacent to this area is also a single bathroom with a shower stall. This room has an acoustical tile ceiling, vinyl sheet

Stair not code compliant. Tower area.

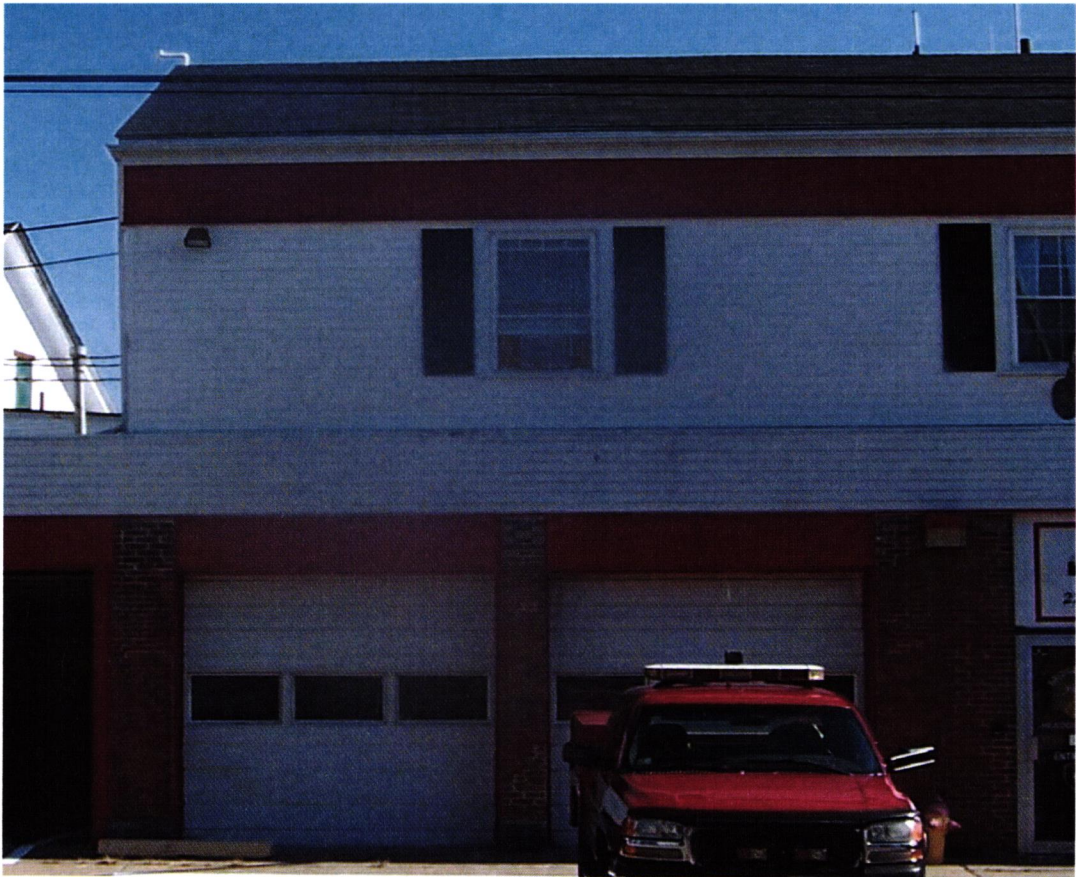
Photo 2.: View of the front section of the original two-story fire station, with the original vertical brick piers beside door openings still visible. What appear to be overhead doors are actually fixed-in-place panels, with interior finished office/command center space within. The Second Floor superstructure, above the low roof level (which is visible at left in the photo), is not original.

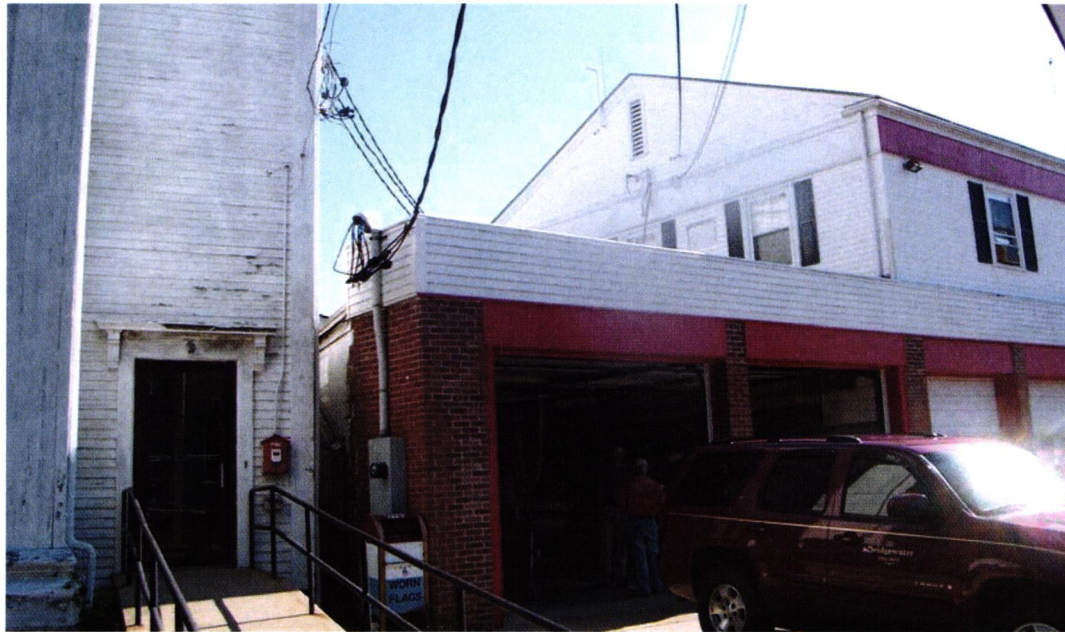
Photo 3.: Far left end of the front of the present station. Just about everything visible, except for the two brick piers at far right (above the vehicle's windshield) is not part of the original building.

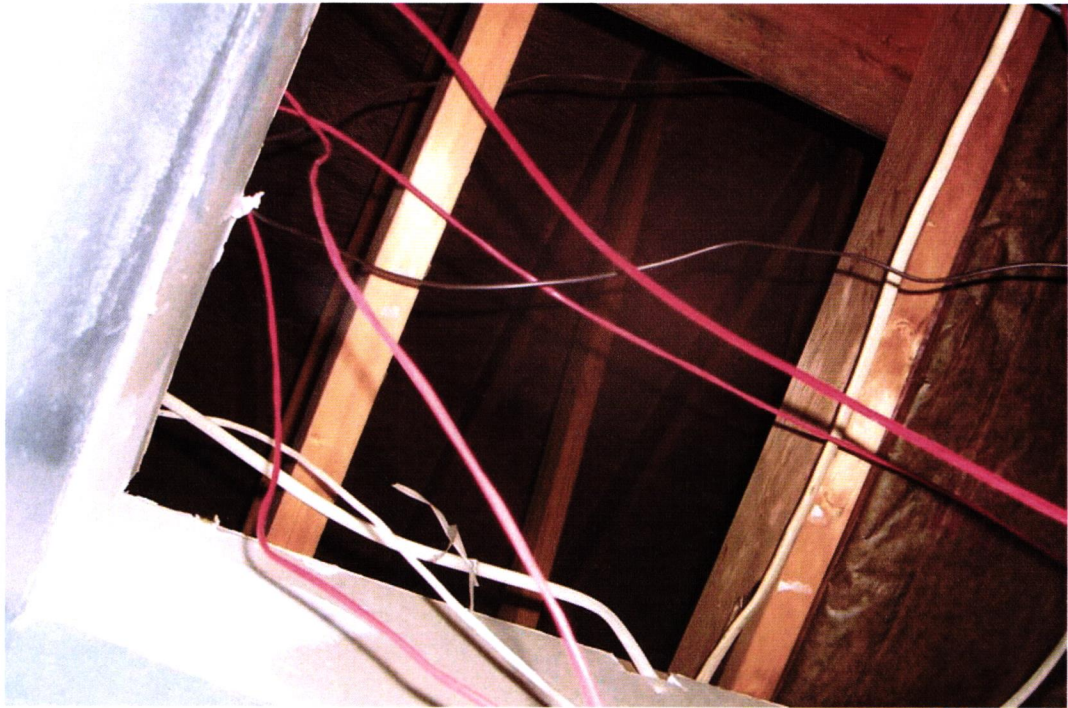
Photo 8.: View above ceiling of Second Floor, showing gable-pitched wood roof truss.

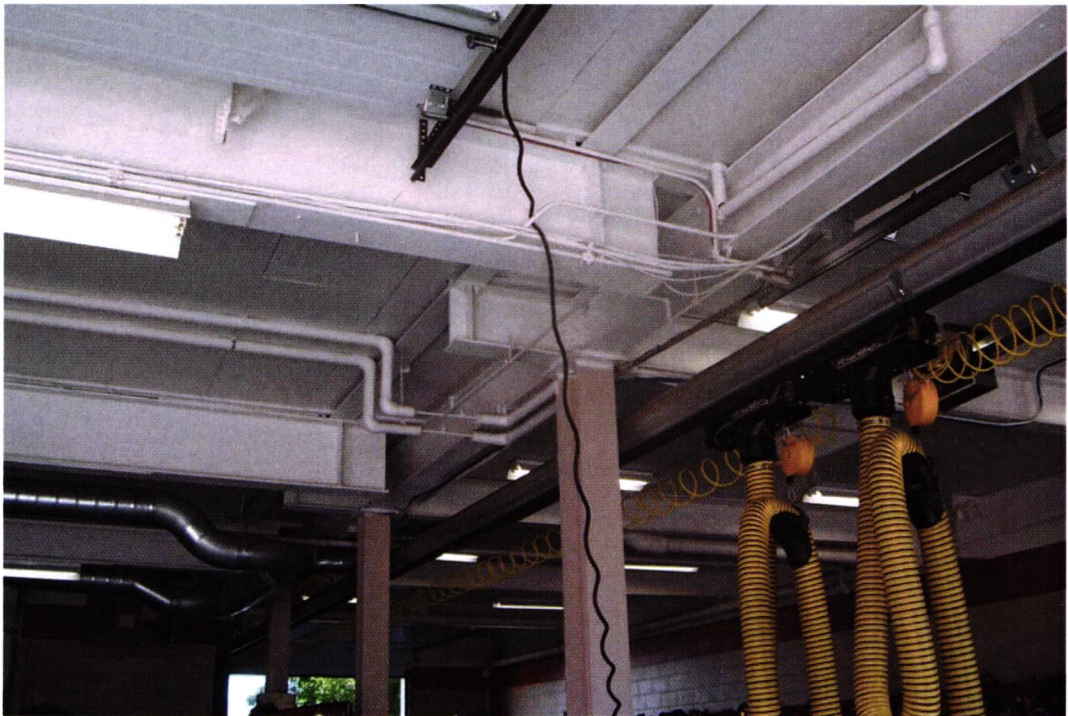
Photo 9.: View of ceiling of Apparatus Room, looking from front of station toward right rear corner. About midway between the black door track at the top center of the photo and the steel beam that extends from the upper right corner down to lower left, can be seen the bottom flange of a steel beam that is parallel to both. This steel beam is aligned with the east end wall of the Second Floor above. The rather complicated framing scheme seen in this photo was accomplished to allow the front-to-back columns line to be moved to the east a short distance, thereby allowing wider apparatus into this space.

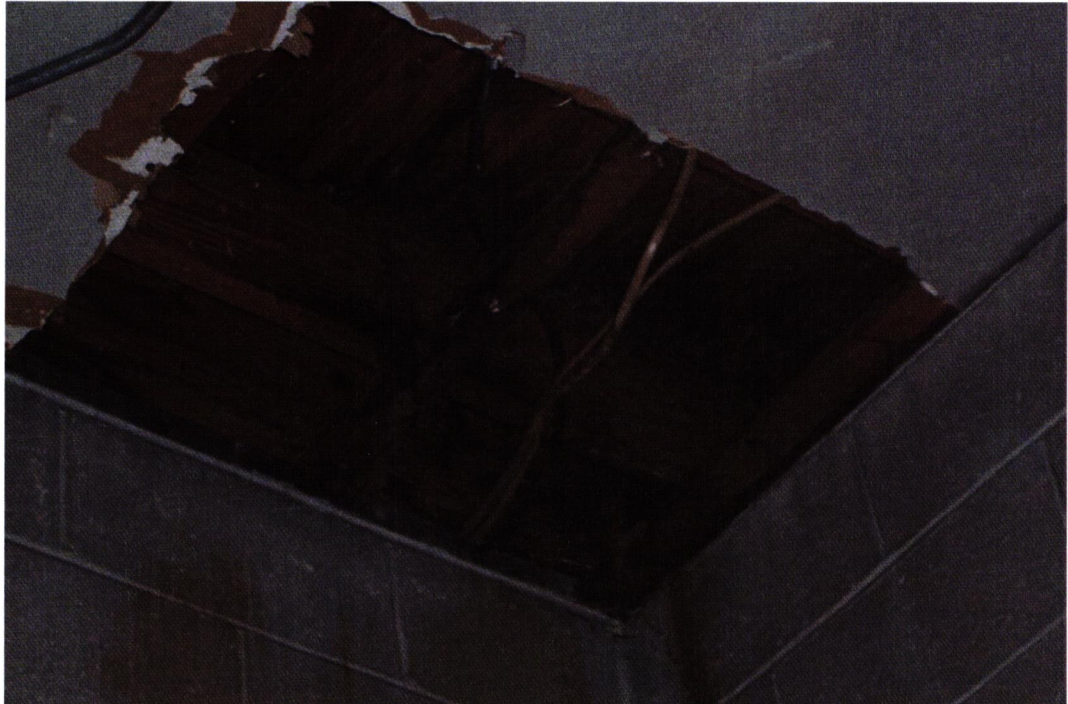
Photo 10.: Underside of roof framing at ceiling of Emergency generator Room.

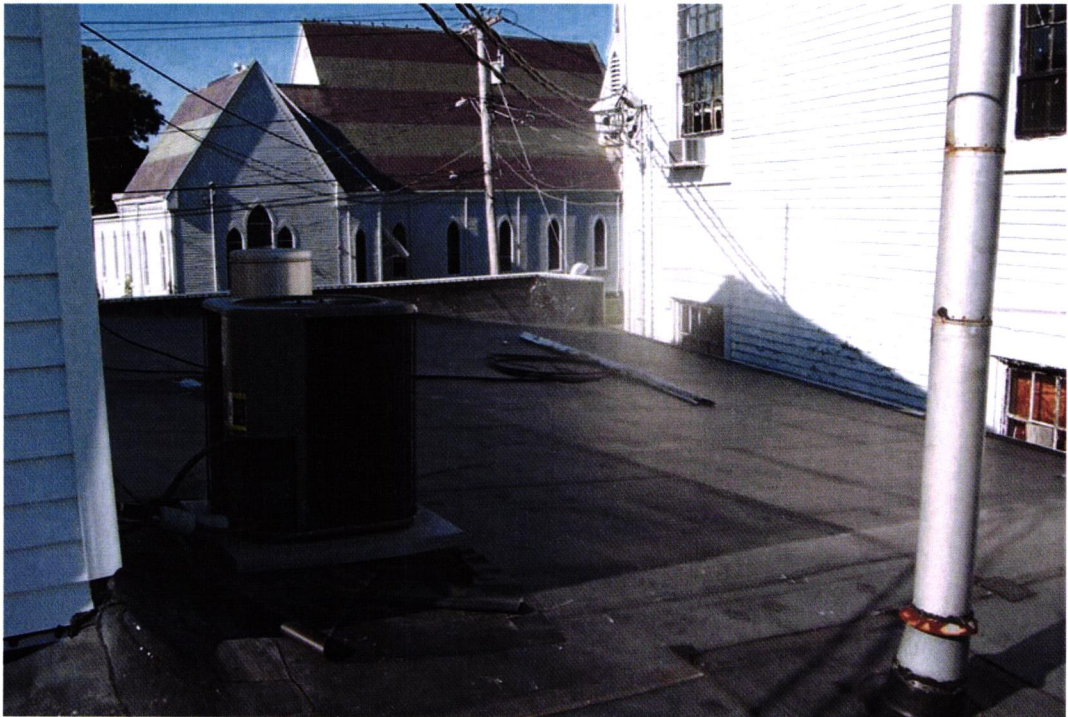
Photo 11.: View of low roof over one-story high west end of station, looking toward School Street. Note steeply-pitched roof for drainage.
