PRELIMINARY BUILDING EVALUATION REPORT

BRIDGEWATER FIRE DEPARTMENT

22 School Street
Bridgewater, Massachusetts

September 9, 2010

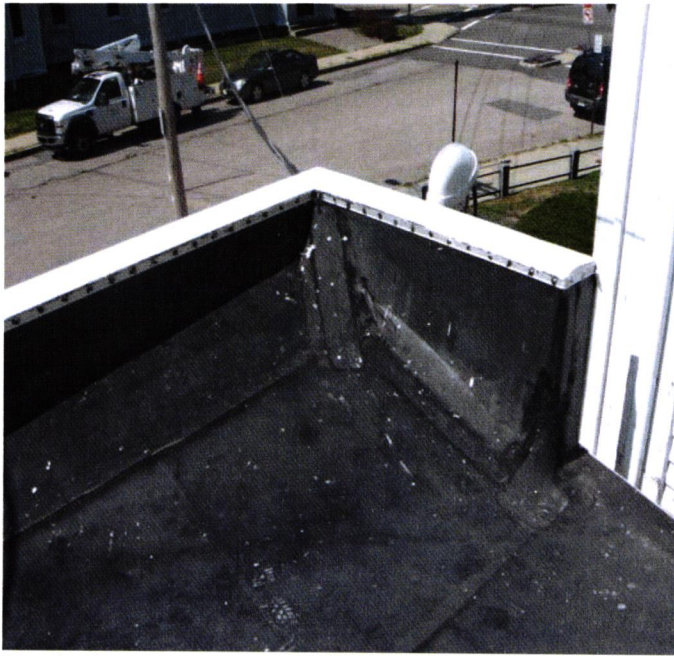
Typical curb flashing detail.

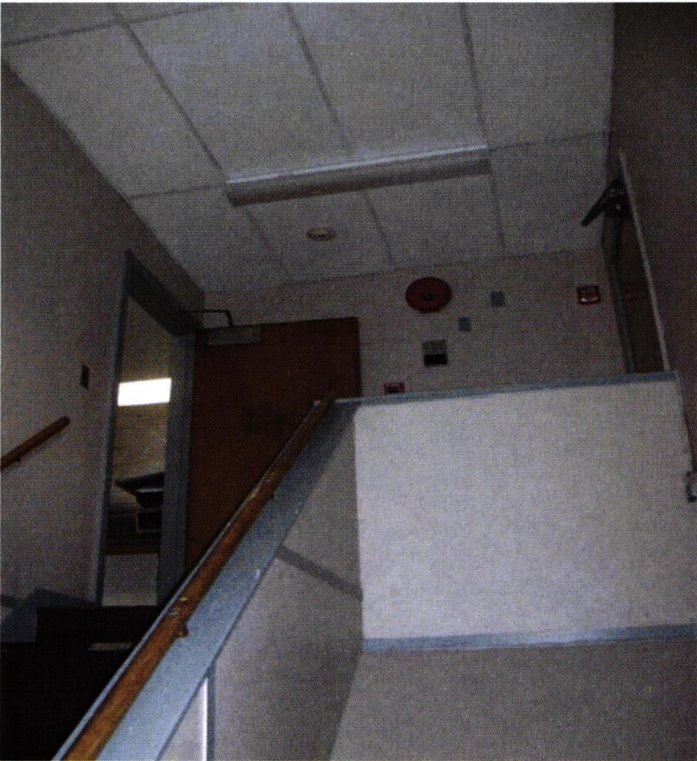
Stairwell.

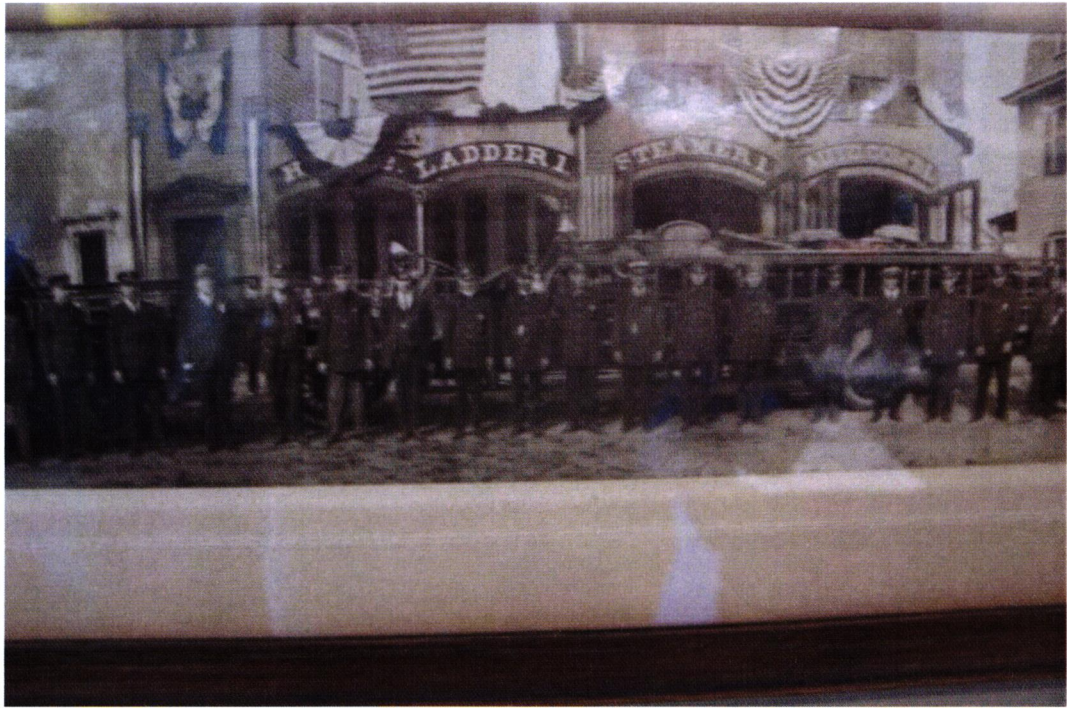
Photo 1.: Early photograph taken at the front of the fire station.

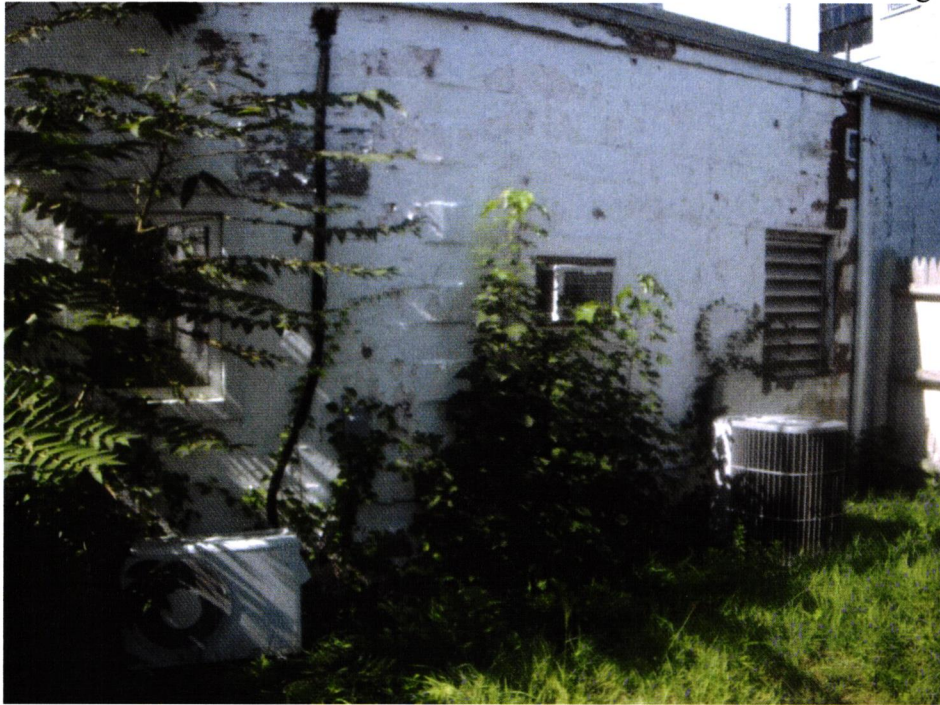
NO. 1

Rooftop Equipment

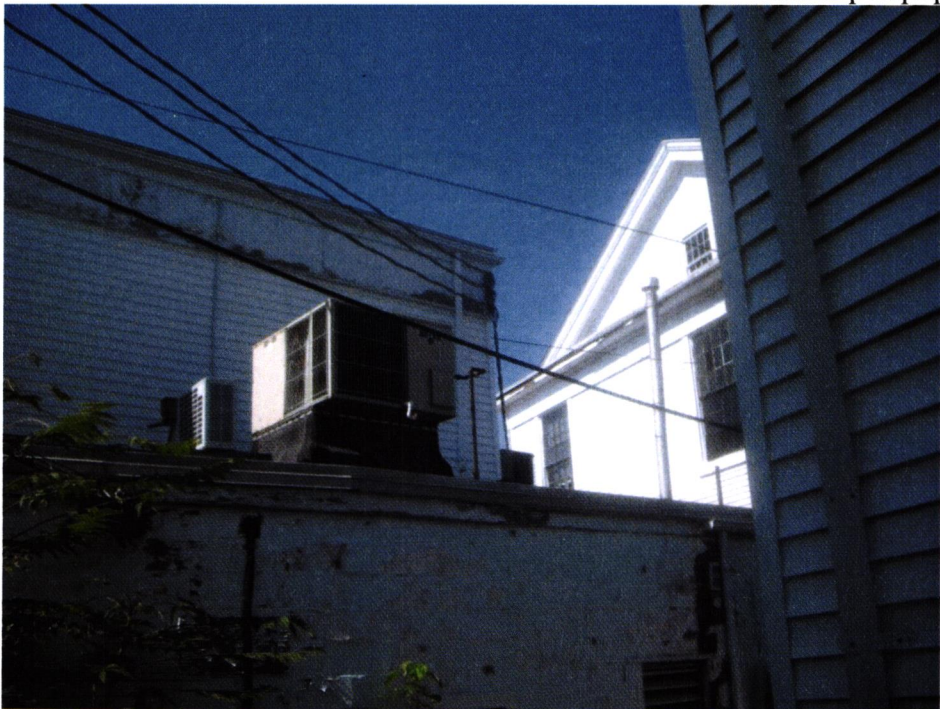
NO. 2

Rooftop Condensing Unit and Generator Flue

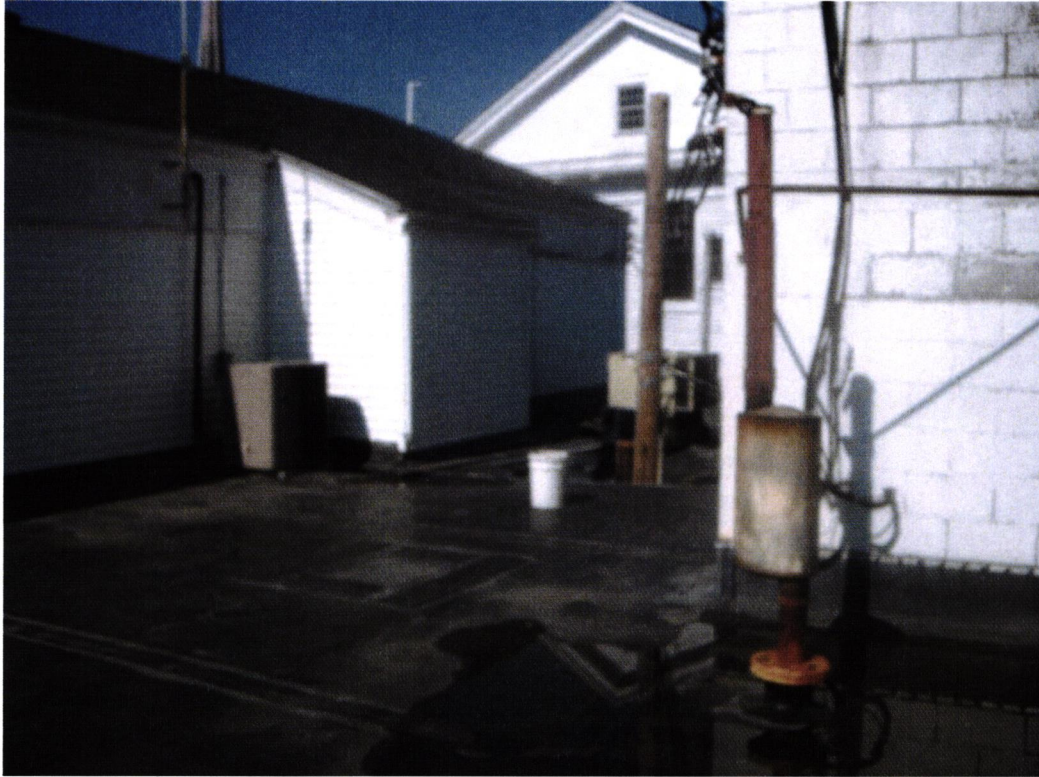
NO. 3

Abandoned Rooftop Unit

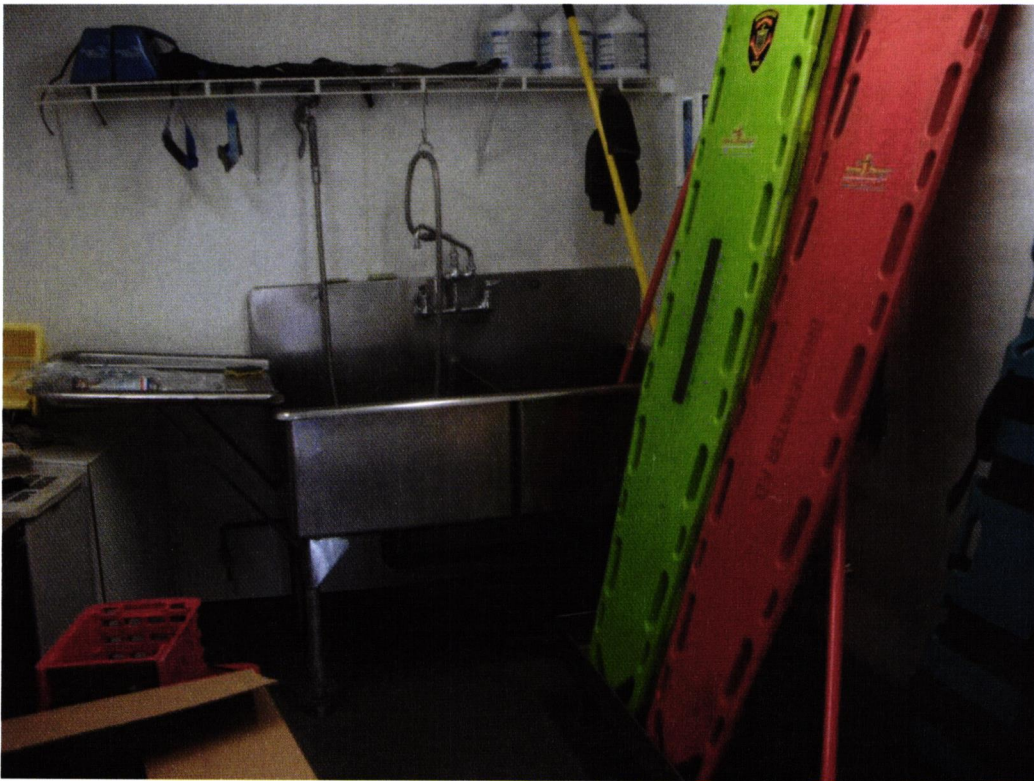
NO. 8

Decontamination Room

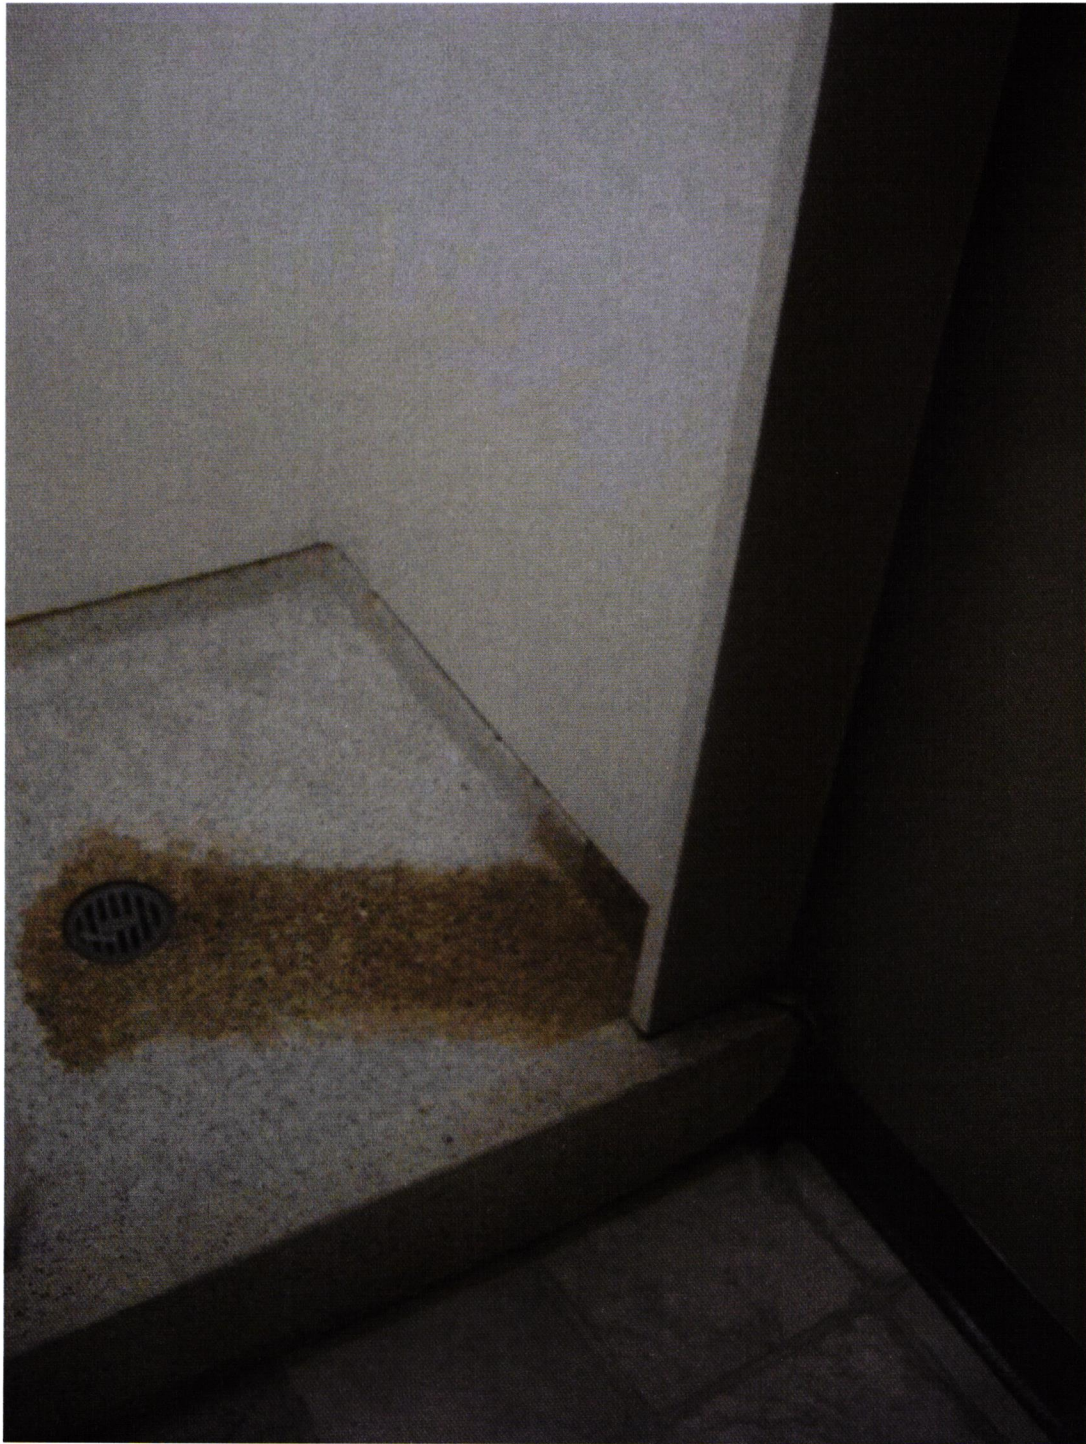
NO. 9

Second Floor Shower

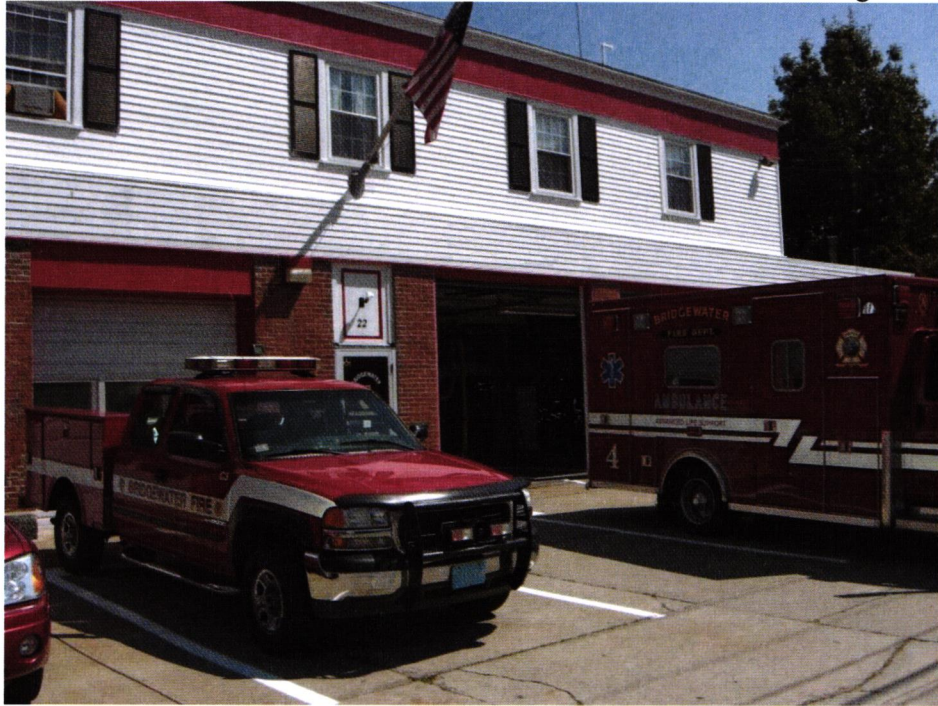
NO. 1

Building Exterior

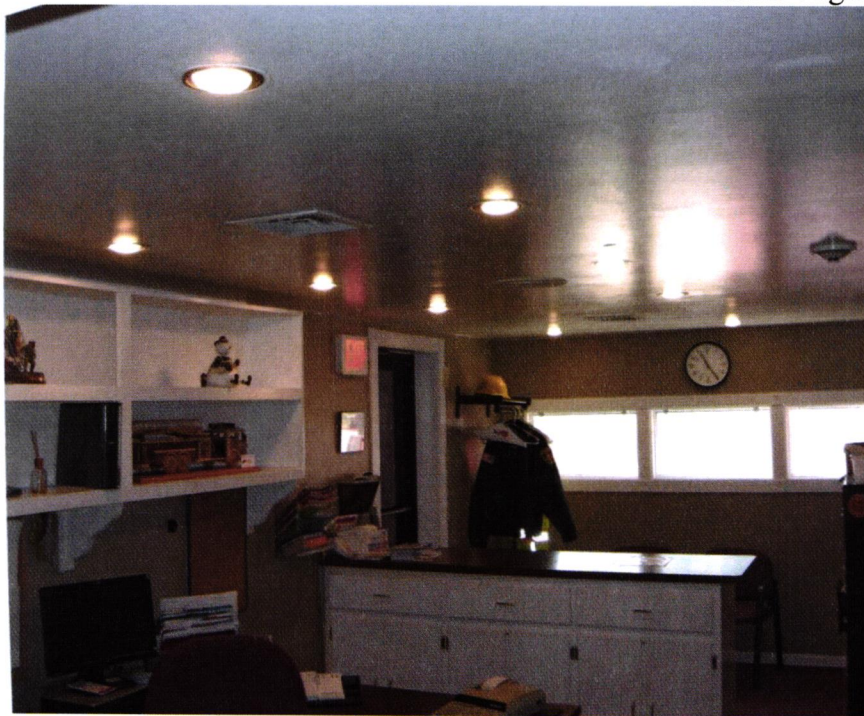
NO. 2

Interior Lighting

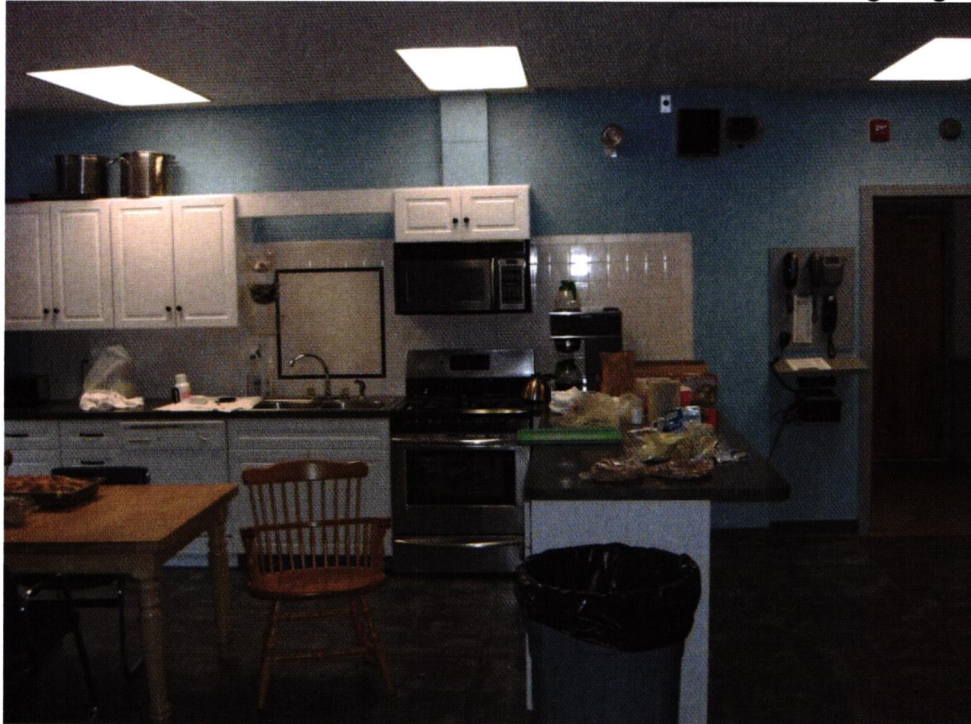
NO. 3

Interior Lighting

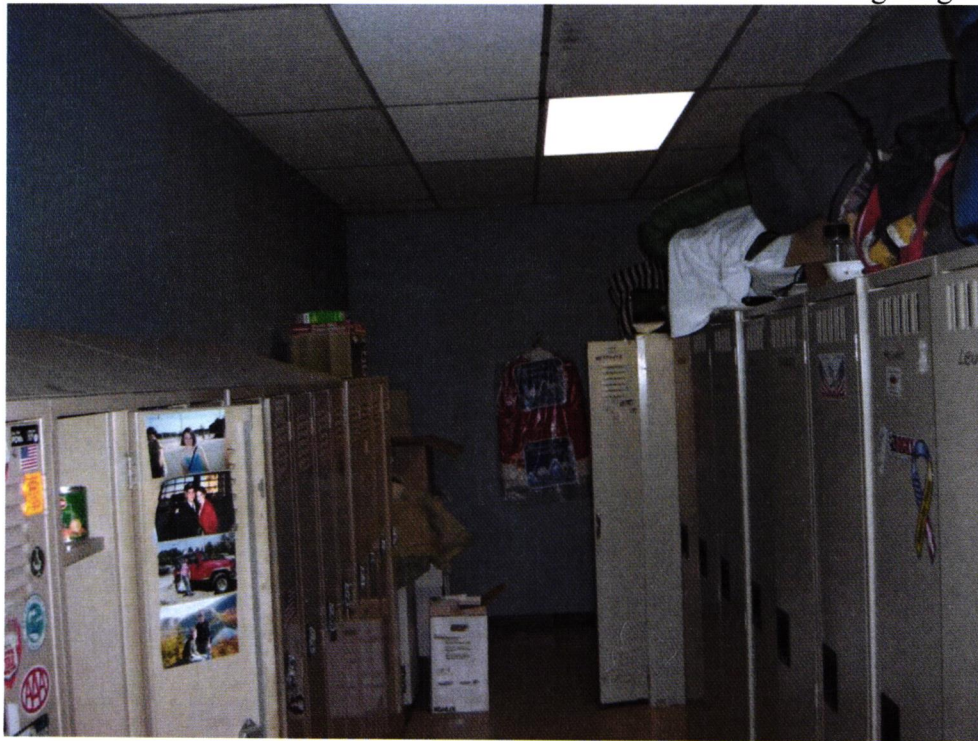
NO. 4

Interior Lighting

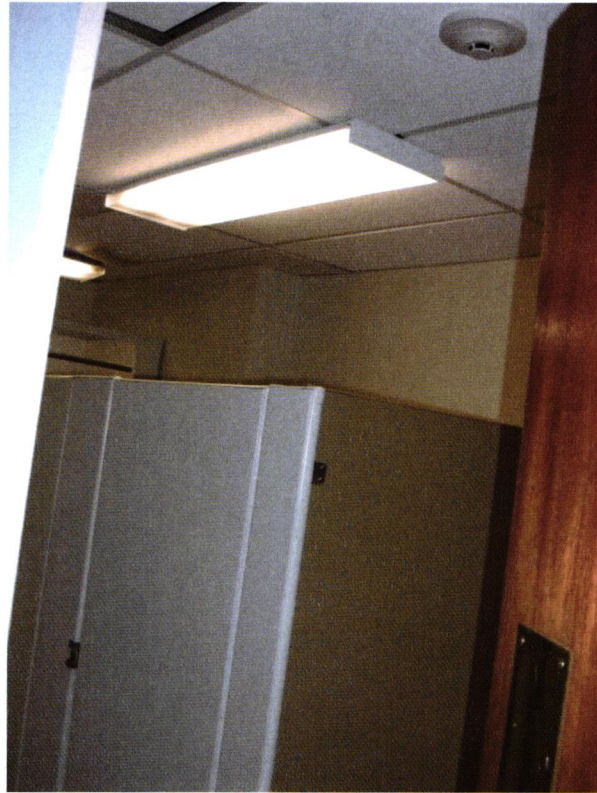
NO. 5

Interior Lighting

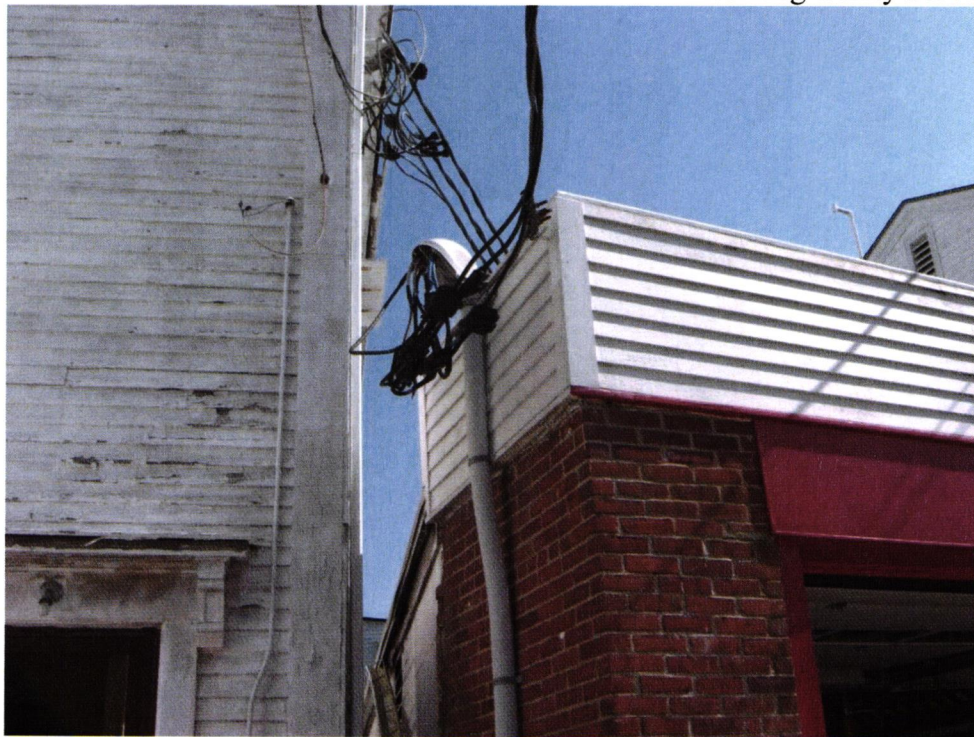
NO. 6

The building is served by a three phase, overhead electrical line. The pole-mounted transformer provides 120/208V three phase 400 amp service which appears to be in good condition. The main service and primary distribution panels were relatively new and in good condition. The existing peak demand over the past 12 months was 28.5 kW which is the equivalent of 80 amps. The existing service should be sufficient to serve the existing building for a future remodel, assuming the size and function of the fire station remains the same.

Incoming Utility Service

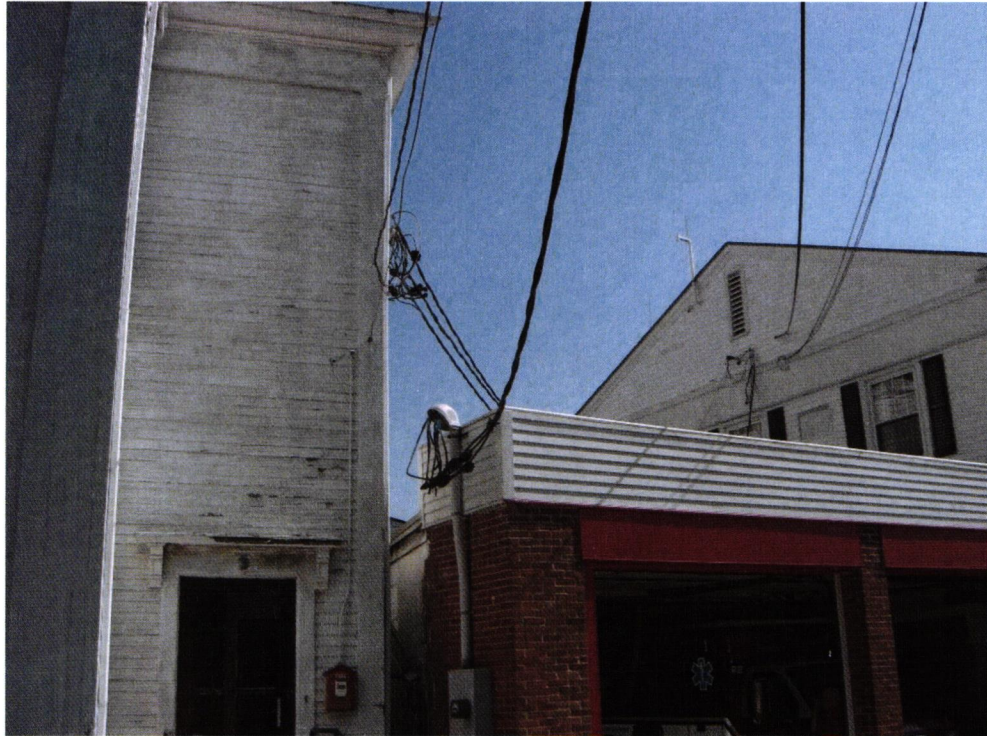
NO. 7

Overhead Electrical Services

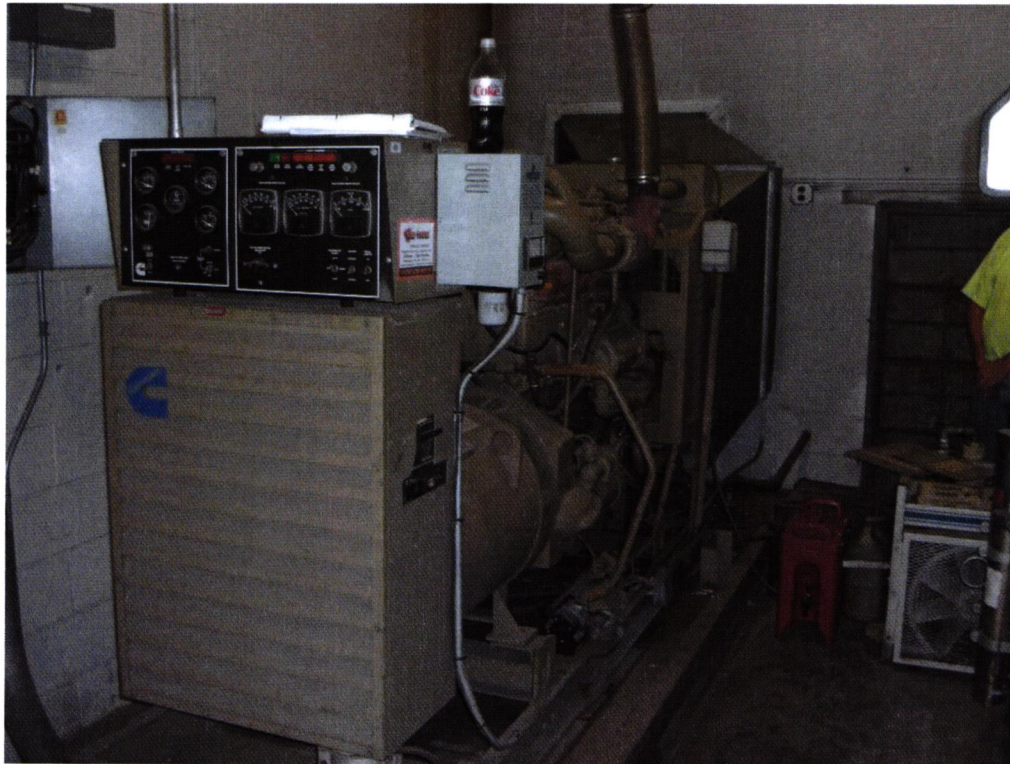
NO. 14

Generator Distribution
